PROJECT No.: SM 230430-G

July 12, 2023

**SLOPE STABILITY ASSESSMENT
PROPOSED SINGLE FAMILY DWELLING
3637 FIRELANE 12
PORT COLBORNE, ONTARIO**

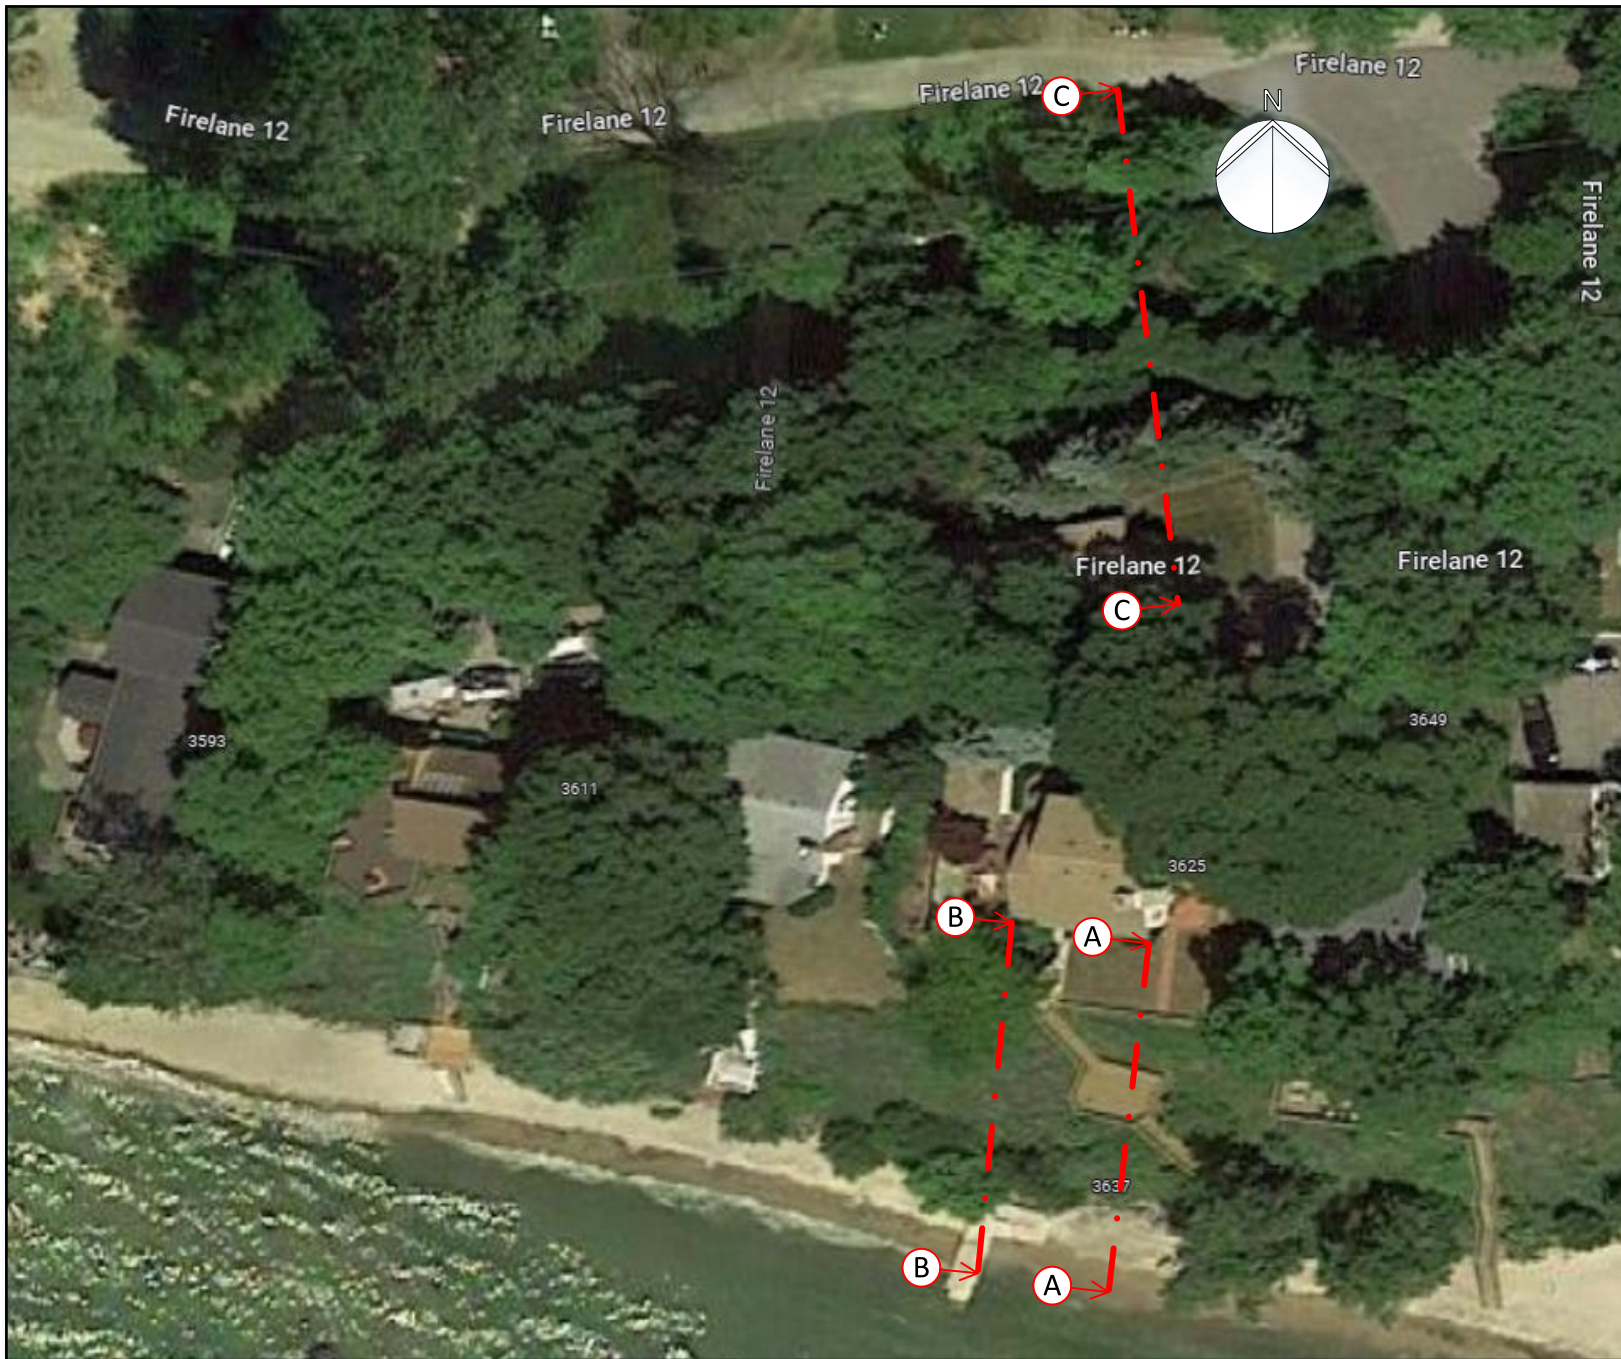
| <p>Drawing No. 1</p> | |

The site was visited initially on June 8, 2023, by a representative of SOIL-MAT ENGINEERS & CONSULTANTS LTD. During our site visit representative slope profiles of the subject slopes were measured from the south east and south west corners of the existing dwelling down to the shore of Lake Erie. A third slope profile was measured from the existing gravel driveway north towards Firelane 12. These profile locations are indicated on the attached Drawing No. 1 and 1A, Slope Profile Location Plans, while the slope profiles are illustrated on the attached Drawing Nos. 2 to 4, Slope Profile A-A to C-C. It is noted that these slope profiles were measured in the field roughly perpendicular to the slope, at locations considered to be representative of the worst case, or steepest, inclination.

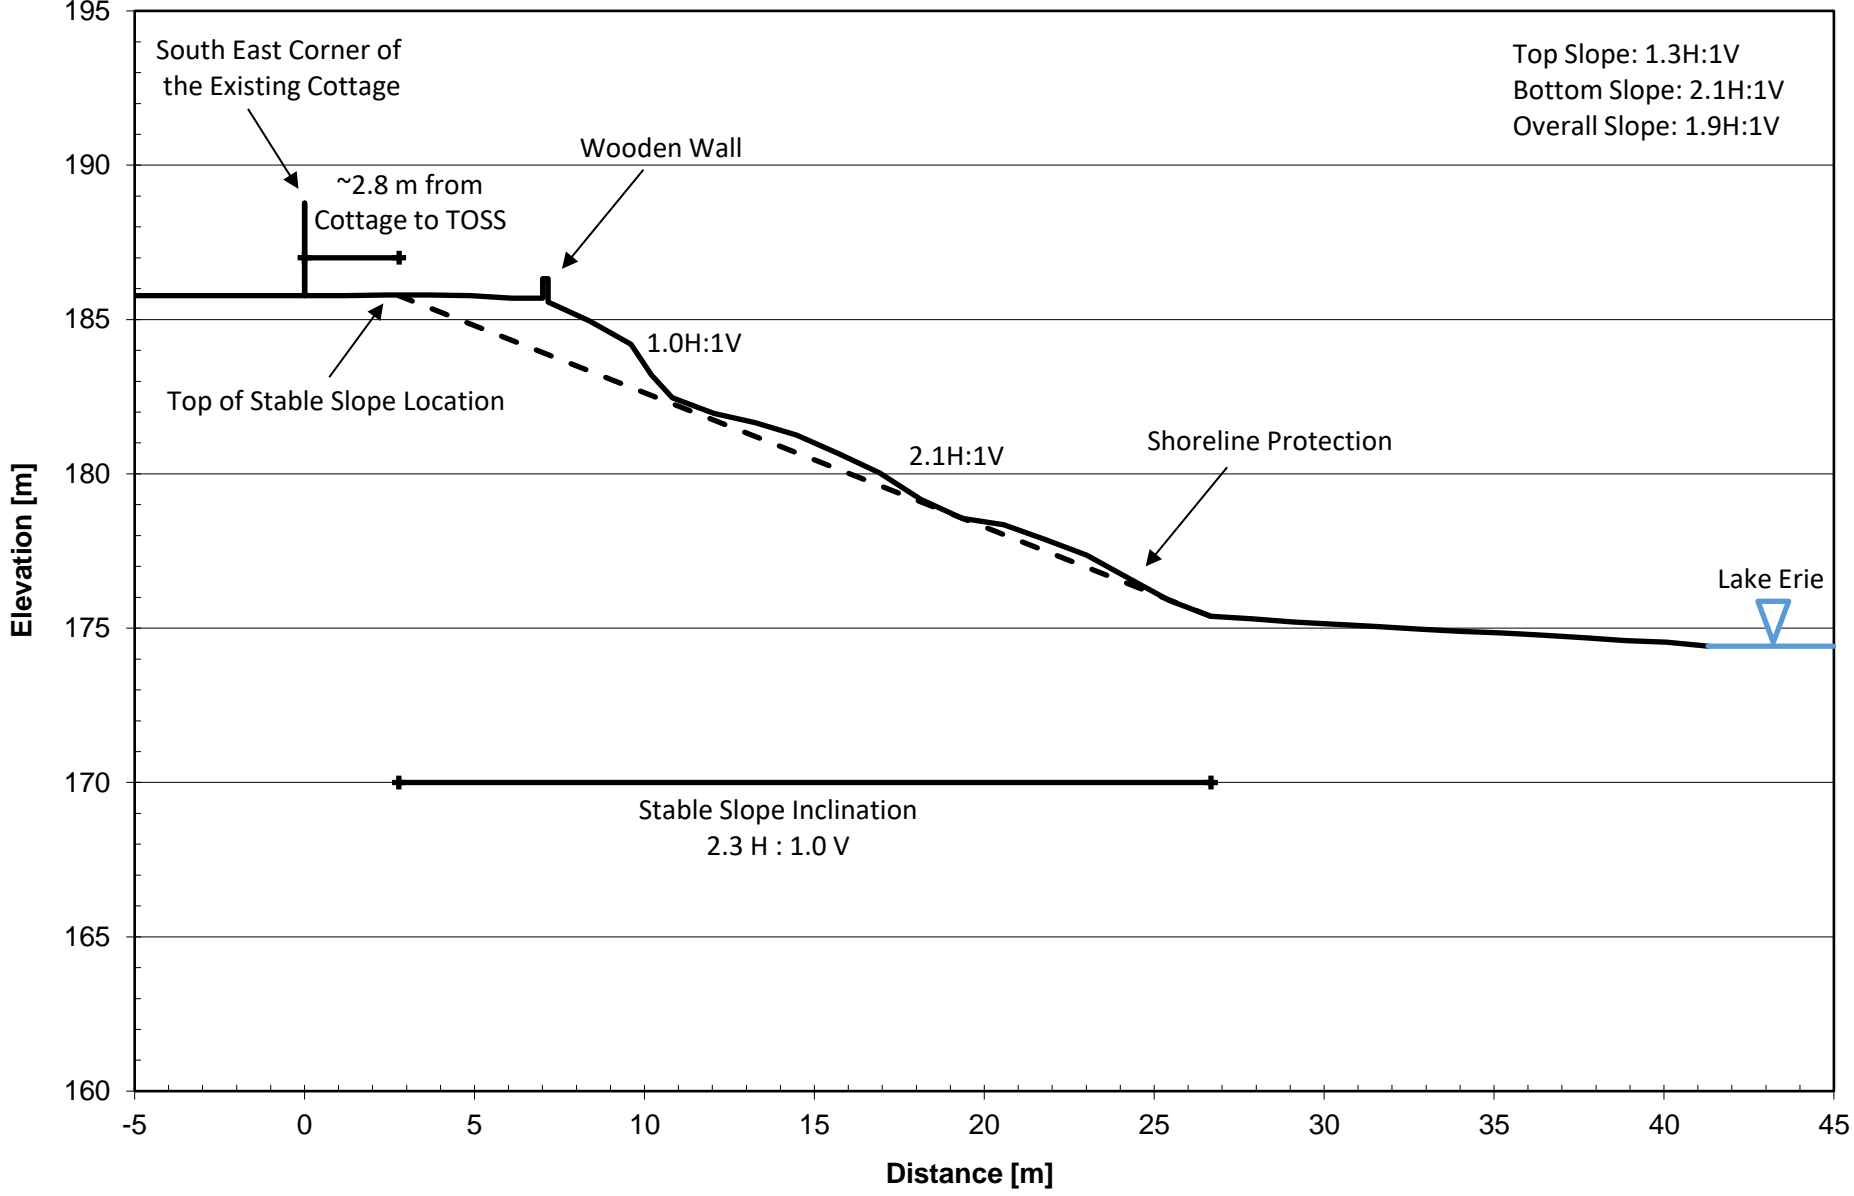
**Slope Profile Section
3637 Firelane 12
Port Colborne, Ontario
Slope Profile A-A**

The southern slope was measured to be approximately 10 to 11 metres in height with overall inclinations of 1.9 to 2.0 horizontal to 1 vertical. The slope was noted to be vegetated with occasional shrubs and covered with scrub vegetation. An armour stone revetment was noted at the toe. The northern slope was measured to be approximately 6 to 7 metres in height with overall inclinations of 2.4 horizontal to 1 vertical. The slope was noted to be well vegetated with young trees and scrub vegetation. No significant evidence of failure scars tension cracks, or other signs of slope instability were noted on either slope at the time of our visit.

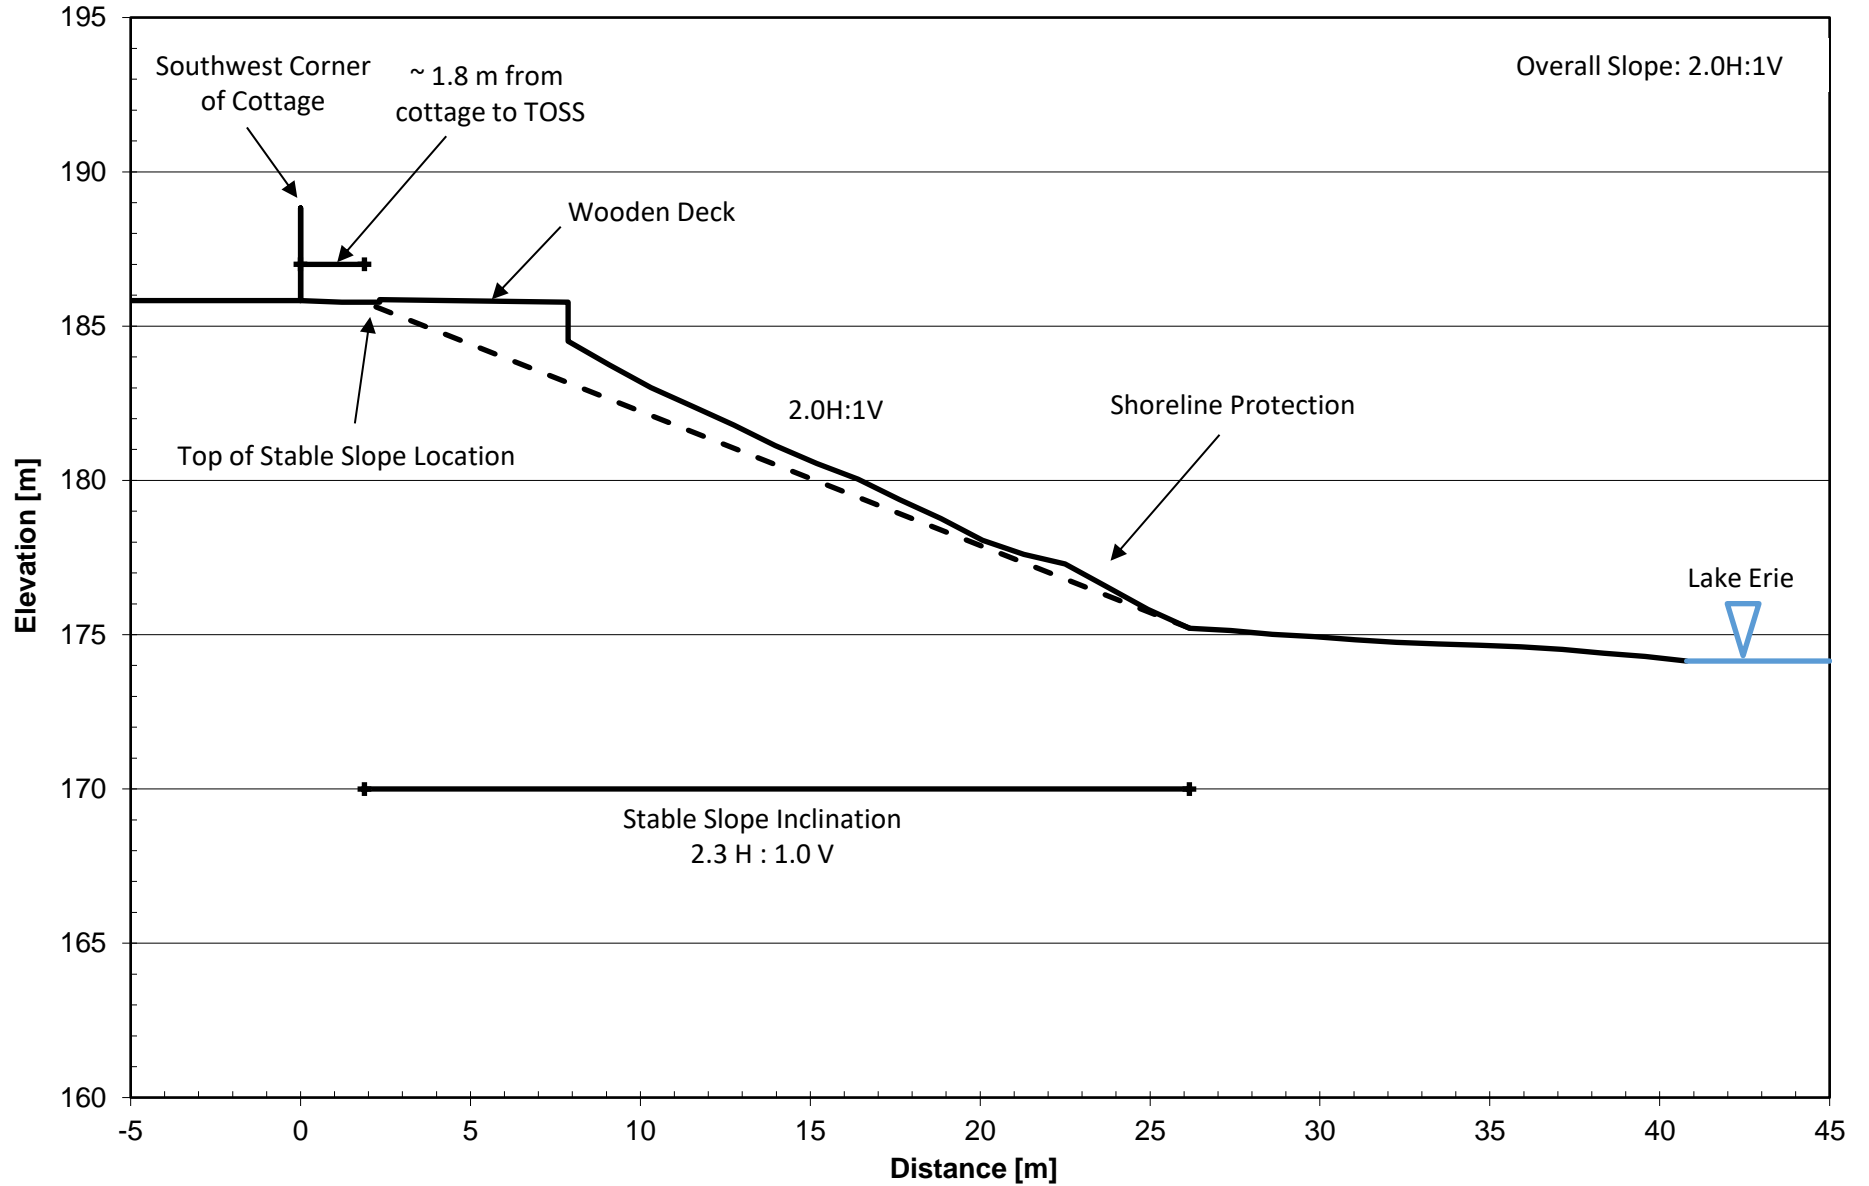
**Slope Profile Section
3637 Firelane 12
Port Colborne, Ontario
Slope Profile B-B**

Based on our analyses using the conservative assumptions noted above, the south subject slope was found to have minimum factors of safety, with respect to the ground surface at the top of stable slope location in the area of profile B-B on the order of 1.48 for normal and 1.38 for elevated groundwater conditions. With respect to the existing structure footprint, or at any depth below the surface at the top of stable slope location, as shown in the attached factor of safety 'heat maps', the factors of safety for normal groundwater conditions are greater than 1.5. The calculated factor of safety for Slope Profile C-C at the top of stable slope location is noted to be on the order of 1.42 and 1.38 for normal and elevated groundwater conditions, respectively.
