# SOIL-MAT ENGINEERS & CONSULTANTS LTD.

**PROJECT No.: SM 240708-G**

Revised: November 19, 2024

**SLOPE STABILITY ASSESSMENT  
PROPOSED NEW SINGLE-FAMILY DWELLING  
3618 FIRELANE 12  
PORT COLBORNE, ONTARIO**

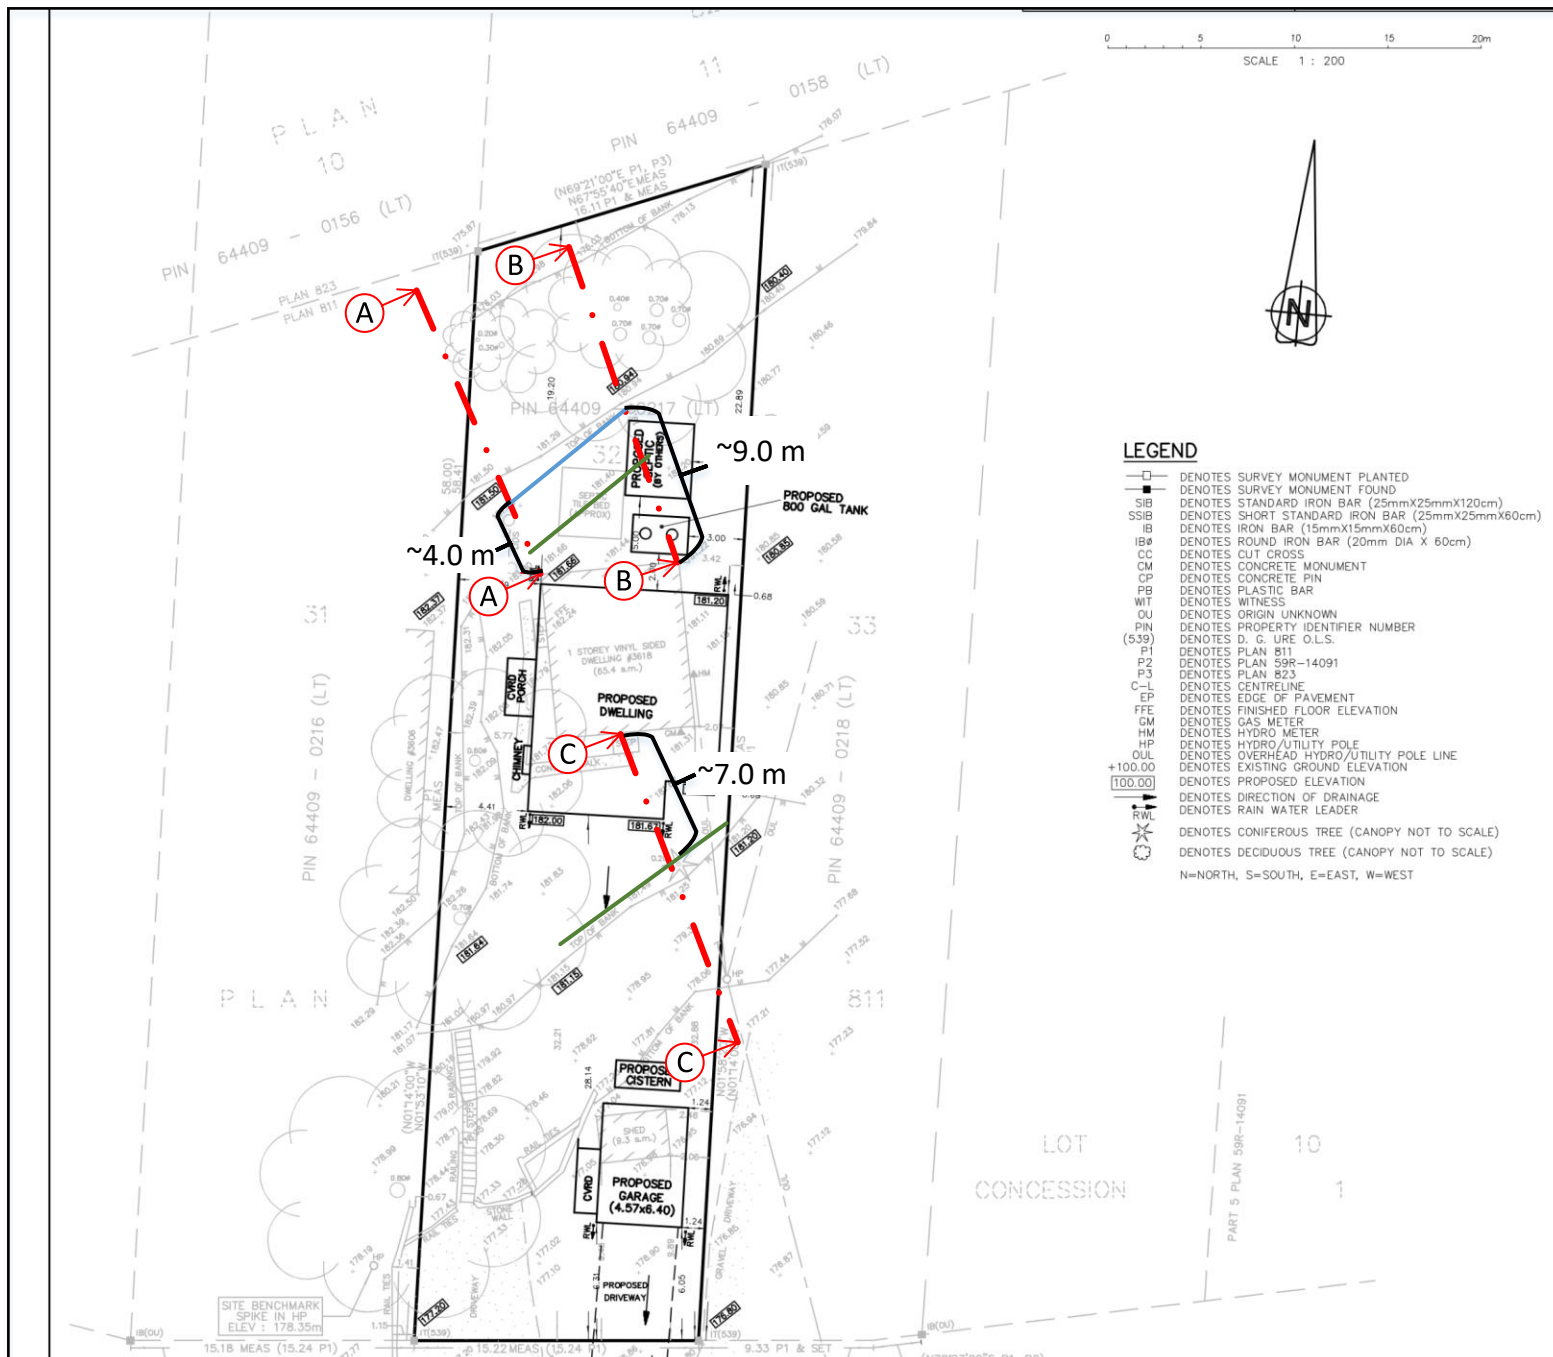
Drawing No. 1

Based on our analyses, using the conservative assumptions noted above, the subject slopes were found to have minimum factors of safety of 1.2 for normal and elevated groundwater conditions, on the north side of the existing structure, locations approximately 4.0 and 9.0 metres north of the existing dwelling, for Profiles A-A and B-B respectively, as illustrated on Drawing No. 1, for the purposes of the proposed septic bed location.

- Excavated soil and/or heavy construction equipment should not be placed or travel near the top of stable slope location. In this regard it is recommended that a silt fence be placed along, or slightly 'uphill' from, the top of stable slope location for the duration of the construction. This will act as a barrier for construction activity and also prevent sediment runoff during construction
- Any drainage towards the slope should be in a controlled fashion, such as sheet flow through well established grass or vegetation, so as to not alter the natural drainage over the slope or create concentrated flows onto the slope.

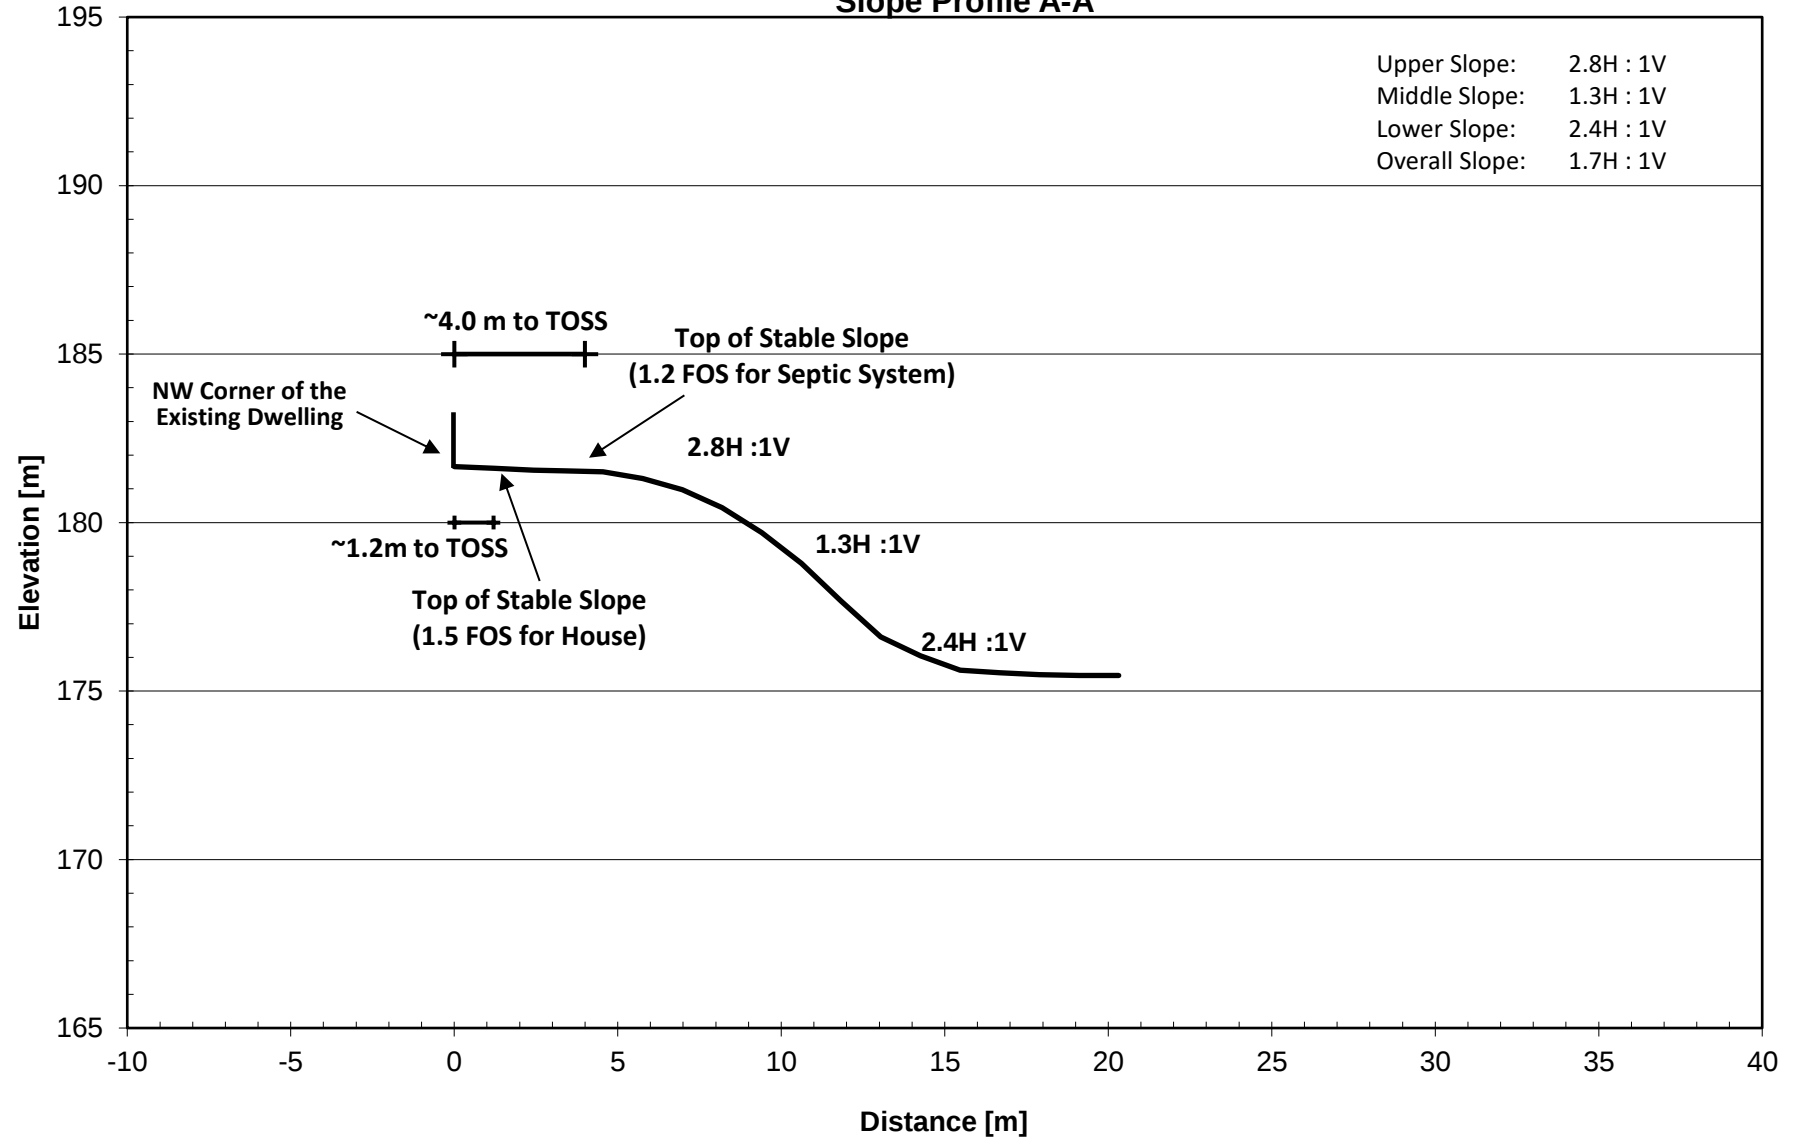
**Slope Profile Section  
3618 Firelane 12  
Port Colborne, Ontario  
Slope Profile A-A**

With respect to the house, and using a factor of safety of 1.5 as a starting point, the top of stable slope location was determined to be at a distance of approximately 1.2 and 6.3 metres north of the existing dwelling for Profiles A-A and B-B respectively, and 7.0 metres south of the existing dwelling for Profile C-C, as illustrated on Drawing No. 1. Sample results of these analysis are attached to the end of this report. It is noted that theoretical surficial planes with lower factors of safety would exist, however these insignificant failure planes do not account for the stabilising effect of vegetation, nor would they impact the global stability of the slope.

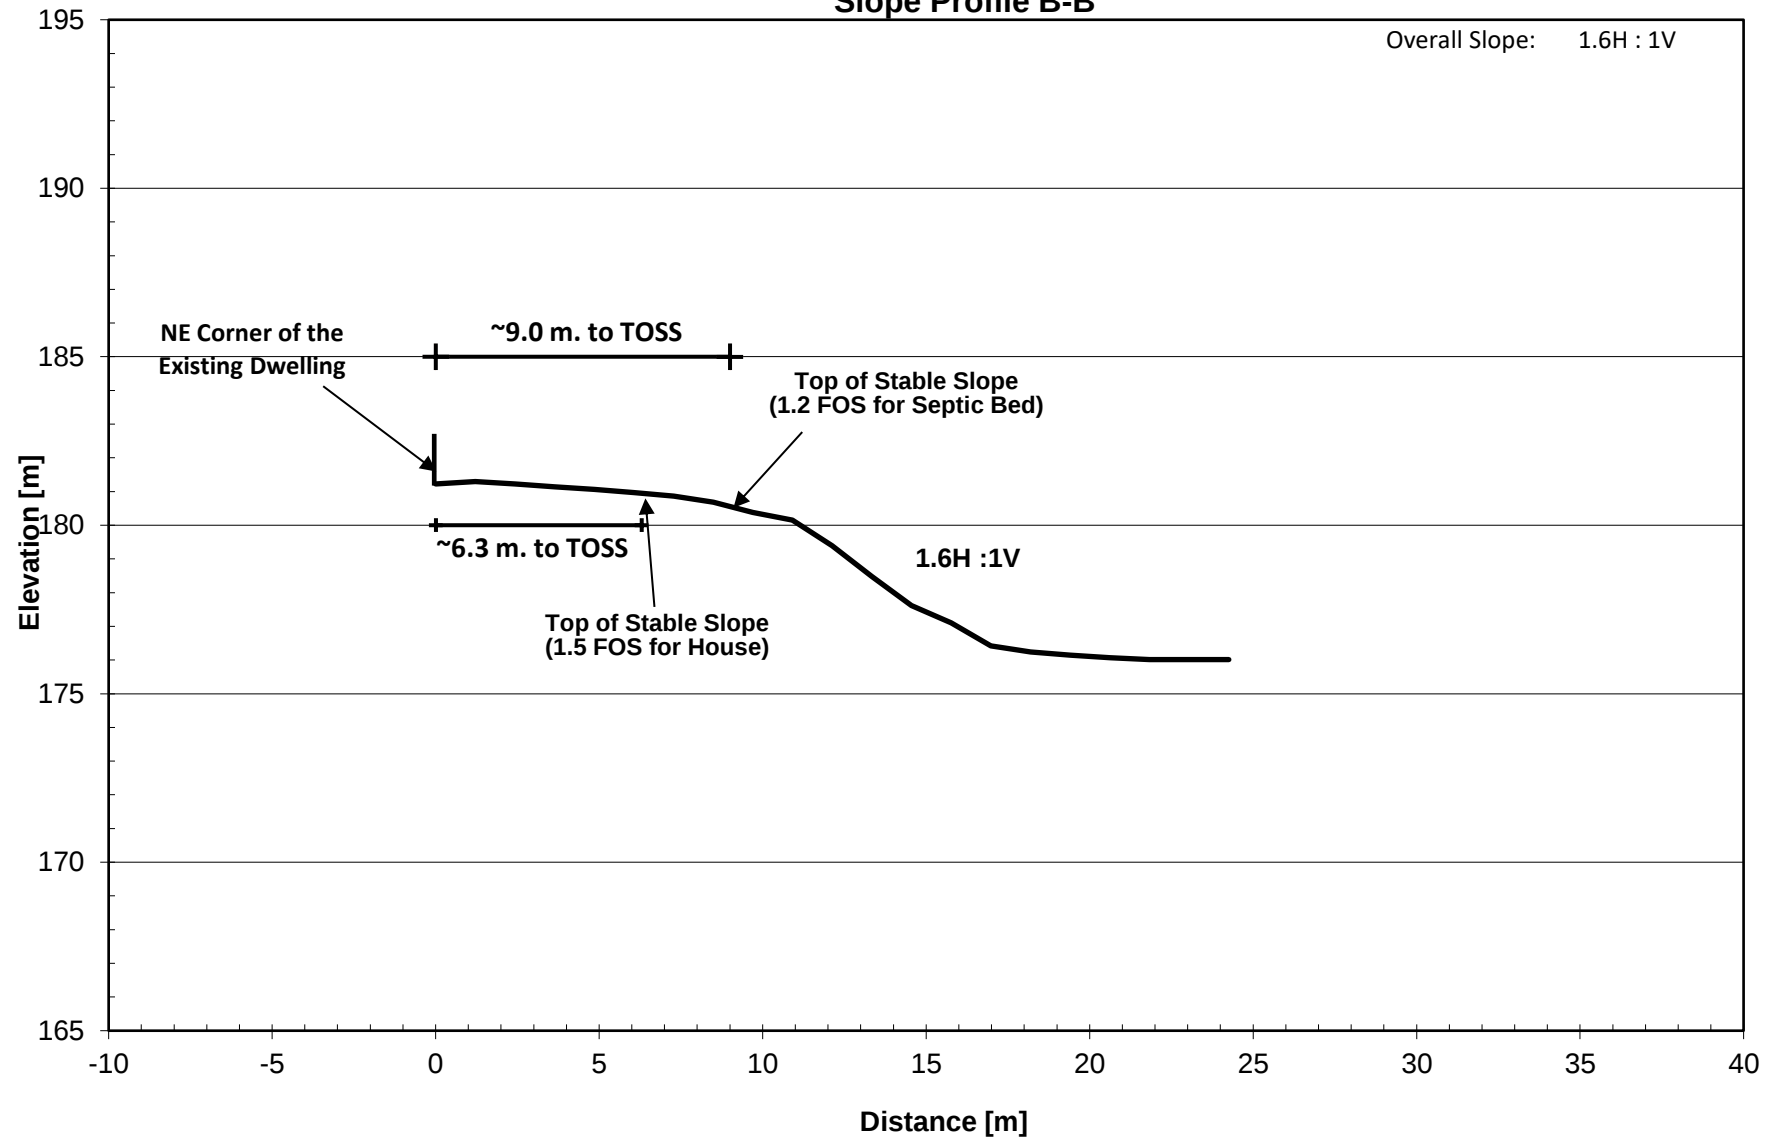
**Slope Profile Section  
3618 Firelane 12  
Port Colborne, Ontario  
Slope Profile B-B**

Overall Slope: 1.6H : 1V

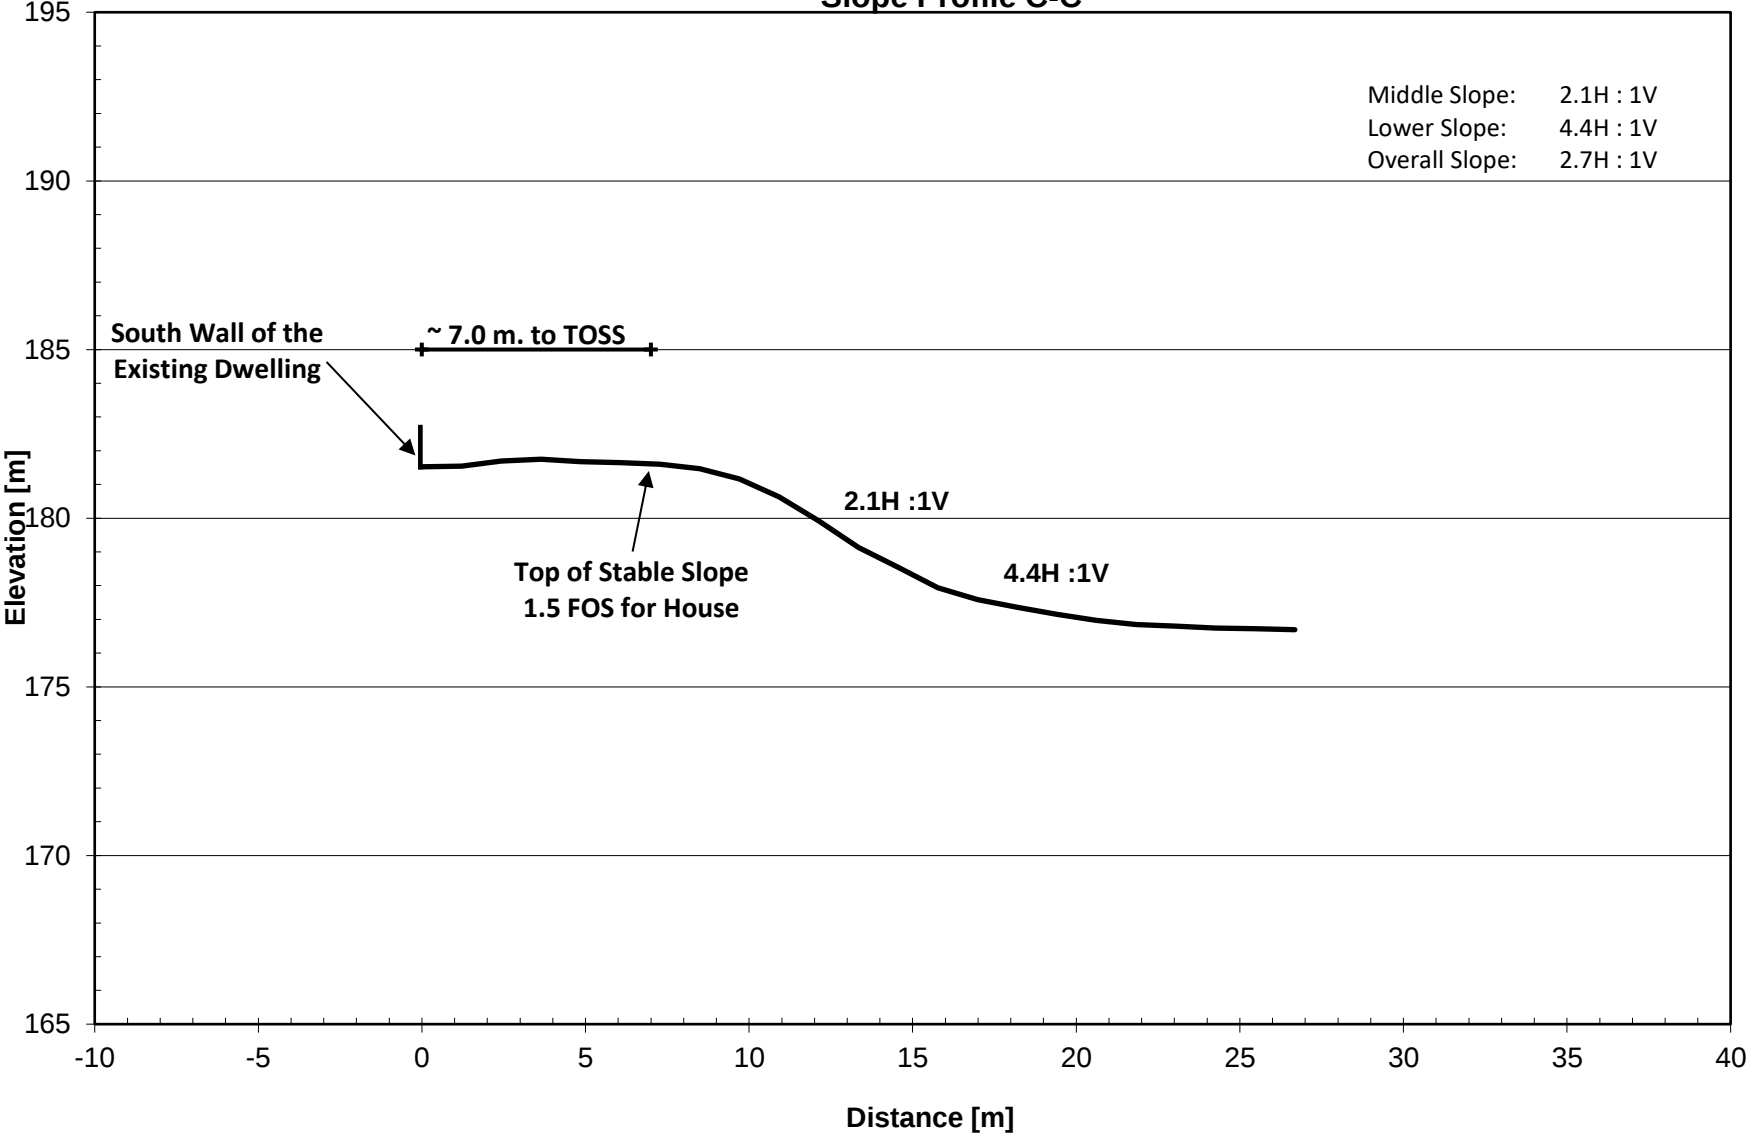
**Slope Profile Section  
3618 Firelane 12  
Port Colborne, Ontario  
Slope Profile C-C**

Middle Slope: 2.1H : 1V  
Lower Slope: 4.4H : 1V  
Overall Slope: 2.7H : 1V
