Project: VALE HEALTH AND WELLNESS CENTRE  
CITY OF PORT COLBORNE  
2022 ROOF REPAIR

**EXECUTIVE SUMMARY:**

**INVESTIGATION SUPPORTING IMAGES:**

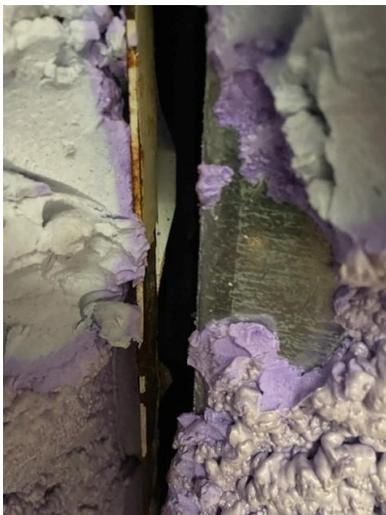
6. When the 2lb spray foam insulation was removed from the bottom of the A1 gutter trough, voids were found between the bottom of the galvanized gutter trough steel and the insulation in various areas.

**Air gap between gutter pan and insulation**

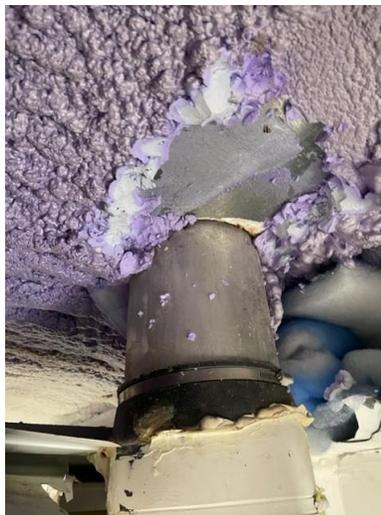
5. When the 2lb CUFCA Certified spray foam insulation was removed from the bottom side of the A1 gutter it appeared to be an inconsistent covering varying from 1"-2.5" thick at a value of R6 per inch.

**Existing 2lb insulation 1.5" thick (R9) (Interior)**

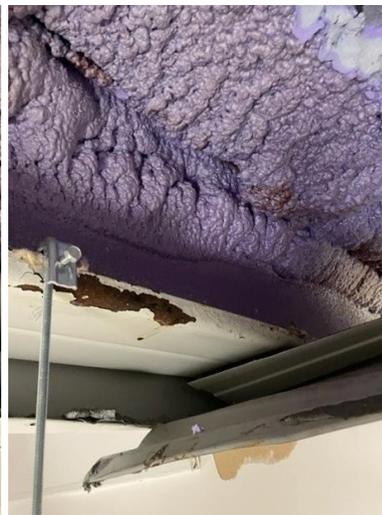
4. Upon further investigation at the interior of the A1 gutter it was found that there was no sufficient termination of the existing AVB/Insulation Liner to the repair created at the bottom side of the gutter with spray foam insulation creating convection/dew point in cold weather conditions.

**Insulation required on back side of C channel (Interior)**

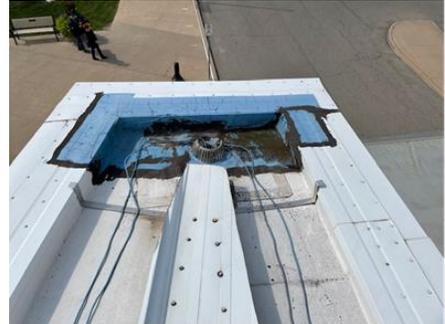
7. Flood testing of the existing A1 drains caused an immediate leak. Removal of the existing drains determined that they are not actually drains but are 8" Stack Jacks that were installed upside down and connected to the existing plumbing with a Fernco. There are no clamping rings, and the membrane was terminated to the SJ flange with EPDM Bonding adhesive and various mastics and sealants. The ISO insulation around the drains was fully saturated with water. The strainers are loose laid on top of these locations

**Existing drains in gutter (6-8" stack jacks)**

3. At the Location of Gutter "A1" Cut, release/remove the existing EPDM liner from the bottom of the gutter, remove ISO insulation beneath it and dispose. Release existing EPDM liner from the sides of the gutter, to remain in place for lap splicing over new EPDM liner. Cut and remove the bottom portion of the existing galvanized steel gutter pan as per detail SK-1. Install new prefabricated steel gutter pan to extend to the bottom of the existing back-to-back "C" channels and secure. Install new 1.5" ISO insulation with LR foam to the bottom and sides of the gutter. Adhere new EPDM Gutter Lining to ISO insulation. Splice existing .045EPDM liner overlapping new EPDM Gutter Lining and apply lap sealant to exposed edge. Remove and Replace 6 drain assemblies and connect with

Furnco at the interior side of the building. Install drain clamping rings and strainers as per manufacturers installation details.

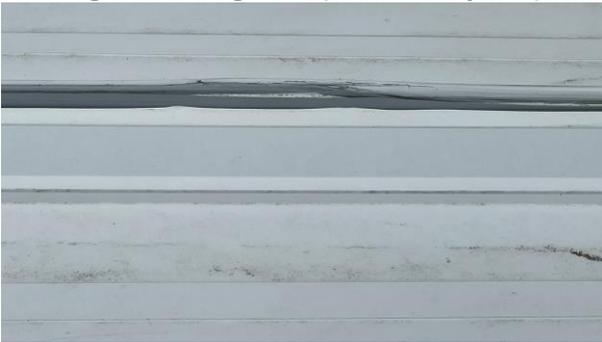
**Existing Gutter Temporary Repair**

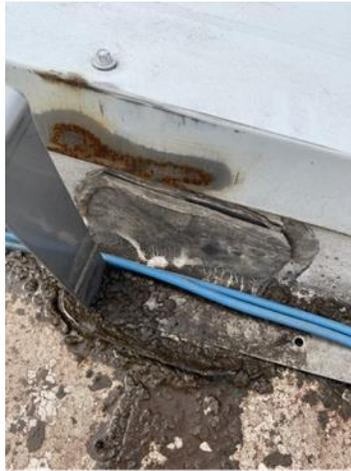
11. Review of all other areas of gutter trough drains determined that the existing EPDM gutter liners have lost adhesion and moved, creased, and tented in areas. There were also failing previously installed repair patches and cover strips.

**Creased South Gutter Liner**

1. At the Location of all other Gutter locations cut, release/remove the existing EPDM liner from the bottom of the gutter and remove ISO insulation beneath it and dispose. Release existing EPDM liner from the sides of the gutter, to remain in place for lap splicing over new EPDM liner. Install new 1.5" ISO insulation with LR foam on the bottom and sides of the gutter. Adhere new EPDM Gutter Lining to ISO insulation. Splice existing .045EPDM liner overlapping new EPDM Gutter Lining and apply lap sealant to exposed edge. Remove and replace 25 drain assemblies and connect with a U-Flow internal pipe seals. Install all clamping rings and strainers as per manufacturers installation details. Replace all damaged water shedding flashings/trims where required.

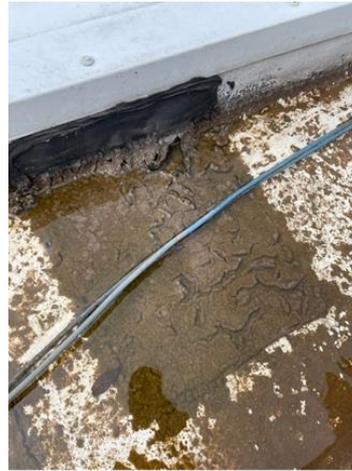
**Failing Gutter Liner Patches**
