Re: Lock 8 Gateway Park Pavilion

A visual review was undertaken at the Lock 8 Gateway Park Pavilion on March 20, 2023. The original construction date is not known. The following details McIntosh Perry's observations and recommendations.

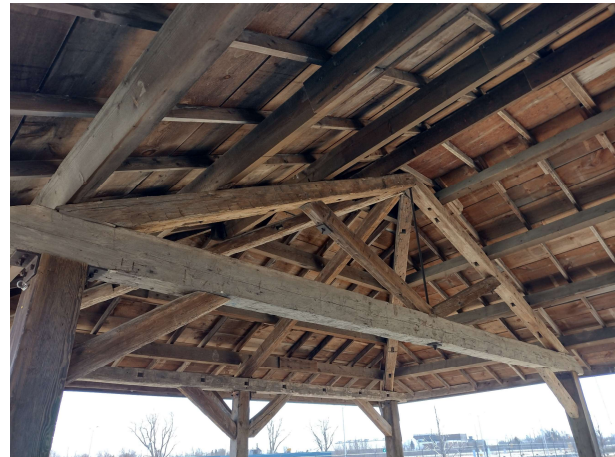
The structure consists of 9"x9" wood columns at approximately 11' on centre along the north, south, and east sides. The columns support rough cut wood trusses, purlins, roof rafters, and decking. Trusses include steel tie rods in the centre. Trusses are through bolted to columns using steel angle clips. Diagonal members between columns and trusses are nailed.

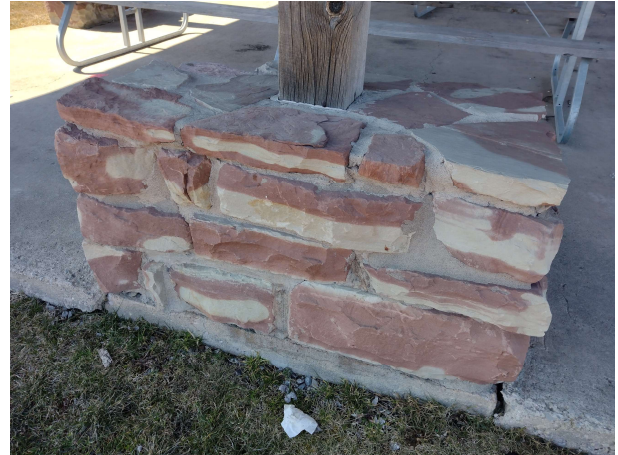
Columns are encased with red sandstone at their bases. Stone bases are presumed to be supported by concrete pads or piers. A concrete slab on grade is installed throughout the pavilion, independent of the concrete pads or piers. Termination of the wood columns is unknown.

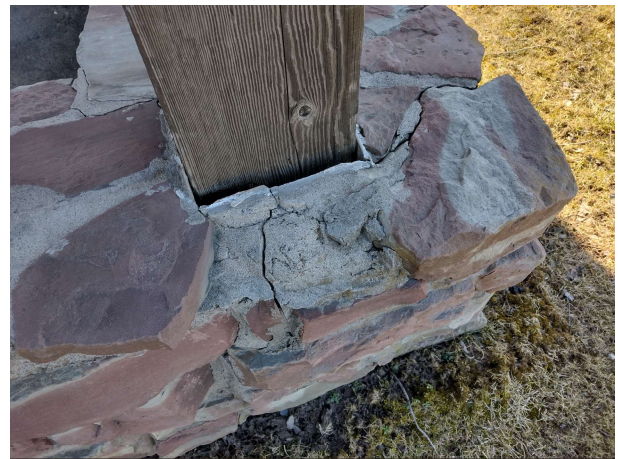
Cracking along mortar joints was noted at all stone bases. Minimal cracking of stones was noted. Cracks range from hairline to approximately 5mm. Mortar between columns and bases has separated. Significant separation between the stone base and wood column was noted at the northwest corner.

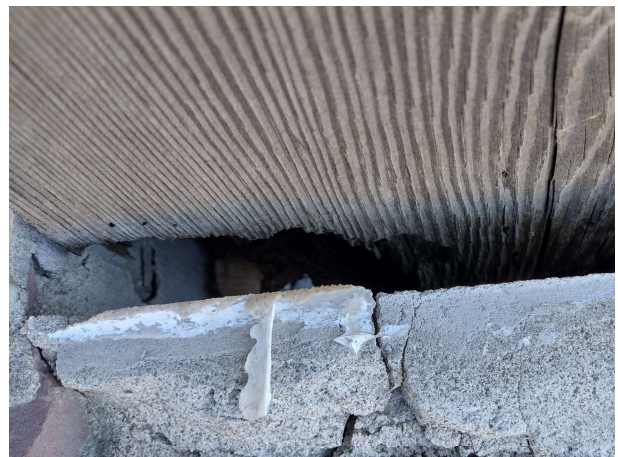
The wood column at the northwest corner is deteriorated where visible within the stone base. There is also notable movement of the column. The column is not supported.

Based on this limited, visual review, the condition of the structure is fair. The degree of deterioration of the remaining five wood column bases is unknown but is presumed to be like what is observed at the northwest column. Detailing of the stone column bases does not allow for water entry, through mortar gaps and the porous nature of the stone and mortar, to drain freely. Column bases are also untreated (preservative not used) which exacerbates the issue.

MP is of the opinion that the structure should not be used in its current state due to unknown conditions of the wood members. It is recommended that the loose metal roofing be removed, or resecured and remaining fasteners be reviewed due to high winds observed. The columns require temporary support until re-design and rebuilding can commence. The checking of the wood members should be monitored as part of maintenance.

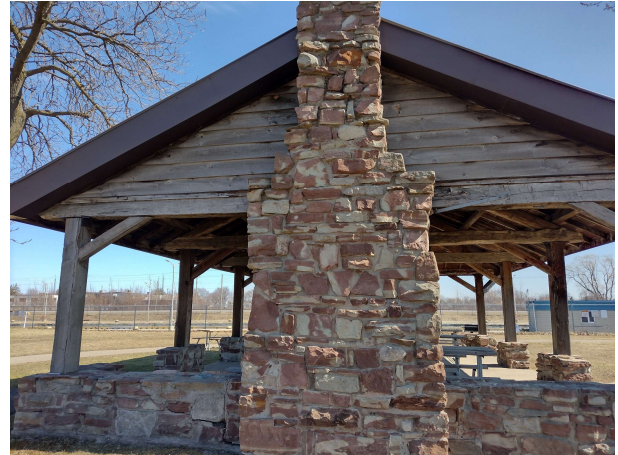
A stone wall, fireplace, and chimney are located along the west side of the Pavilion. Typical mortar cracking was noted at the chimney and north wall.

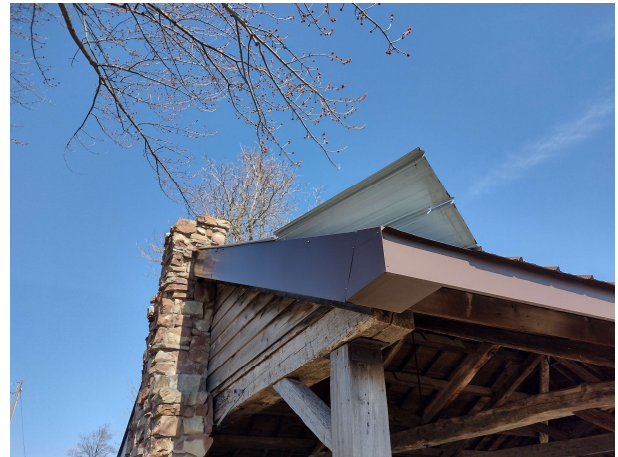
The sloped roof is finished with newer metal panels. A loose section of roofing was noted at the southwest corner.

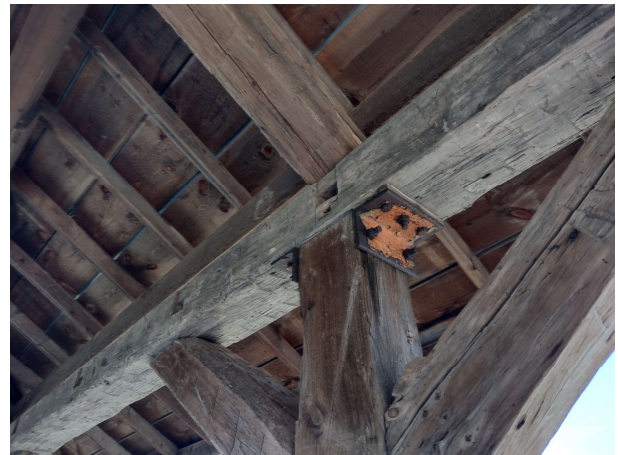
Minimal checking, or splitting, of the wood members was noted. Checking is a common occurrence as wood dries. Checking may have occurred when the wood was processed or in recent years.
