# SOIL-MAT ENGINEERS & CONSULTANTS LTD.

**PROJECT No.: SM 240708-G**

Revised: November 19, 2024

**SLOPE STABILITY ASSESSMENT  
PROPOSED NEW SINGLE-FAMILY DWELLING  
3618 FIRELANE 12  
PORT COLBORNE, ONTARIO**

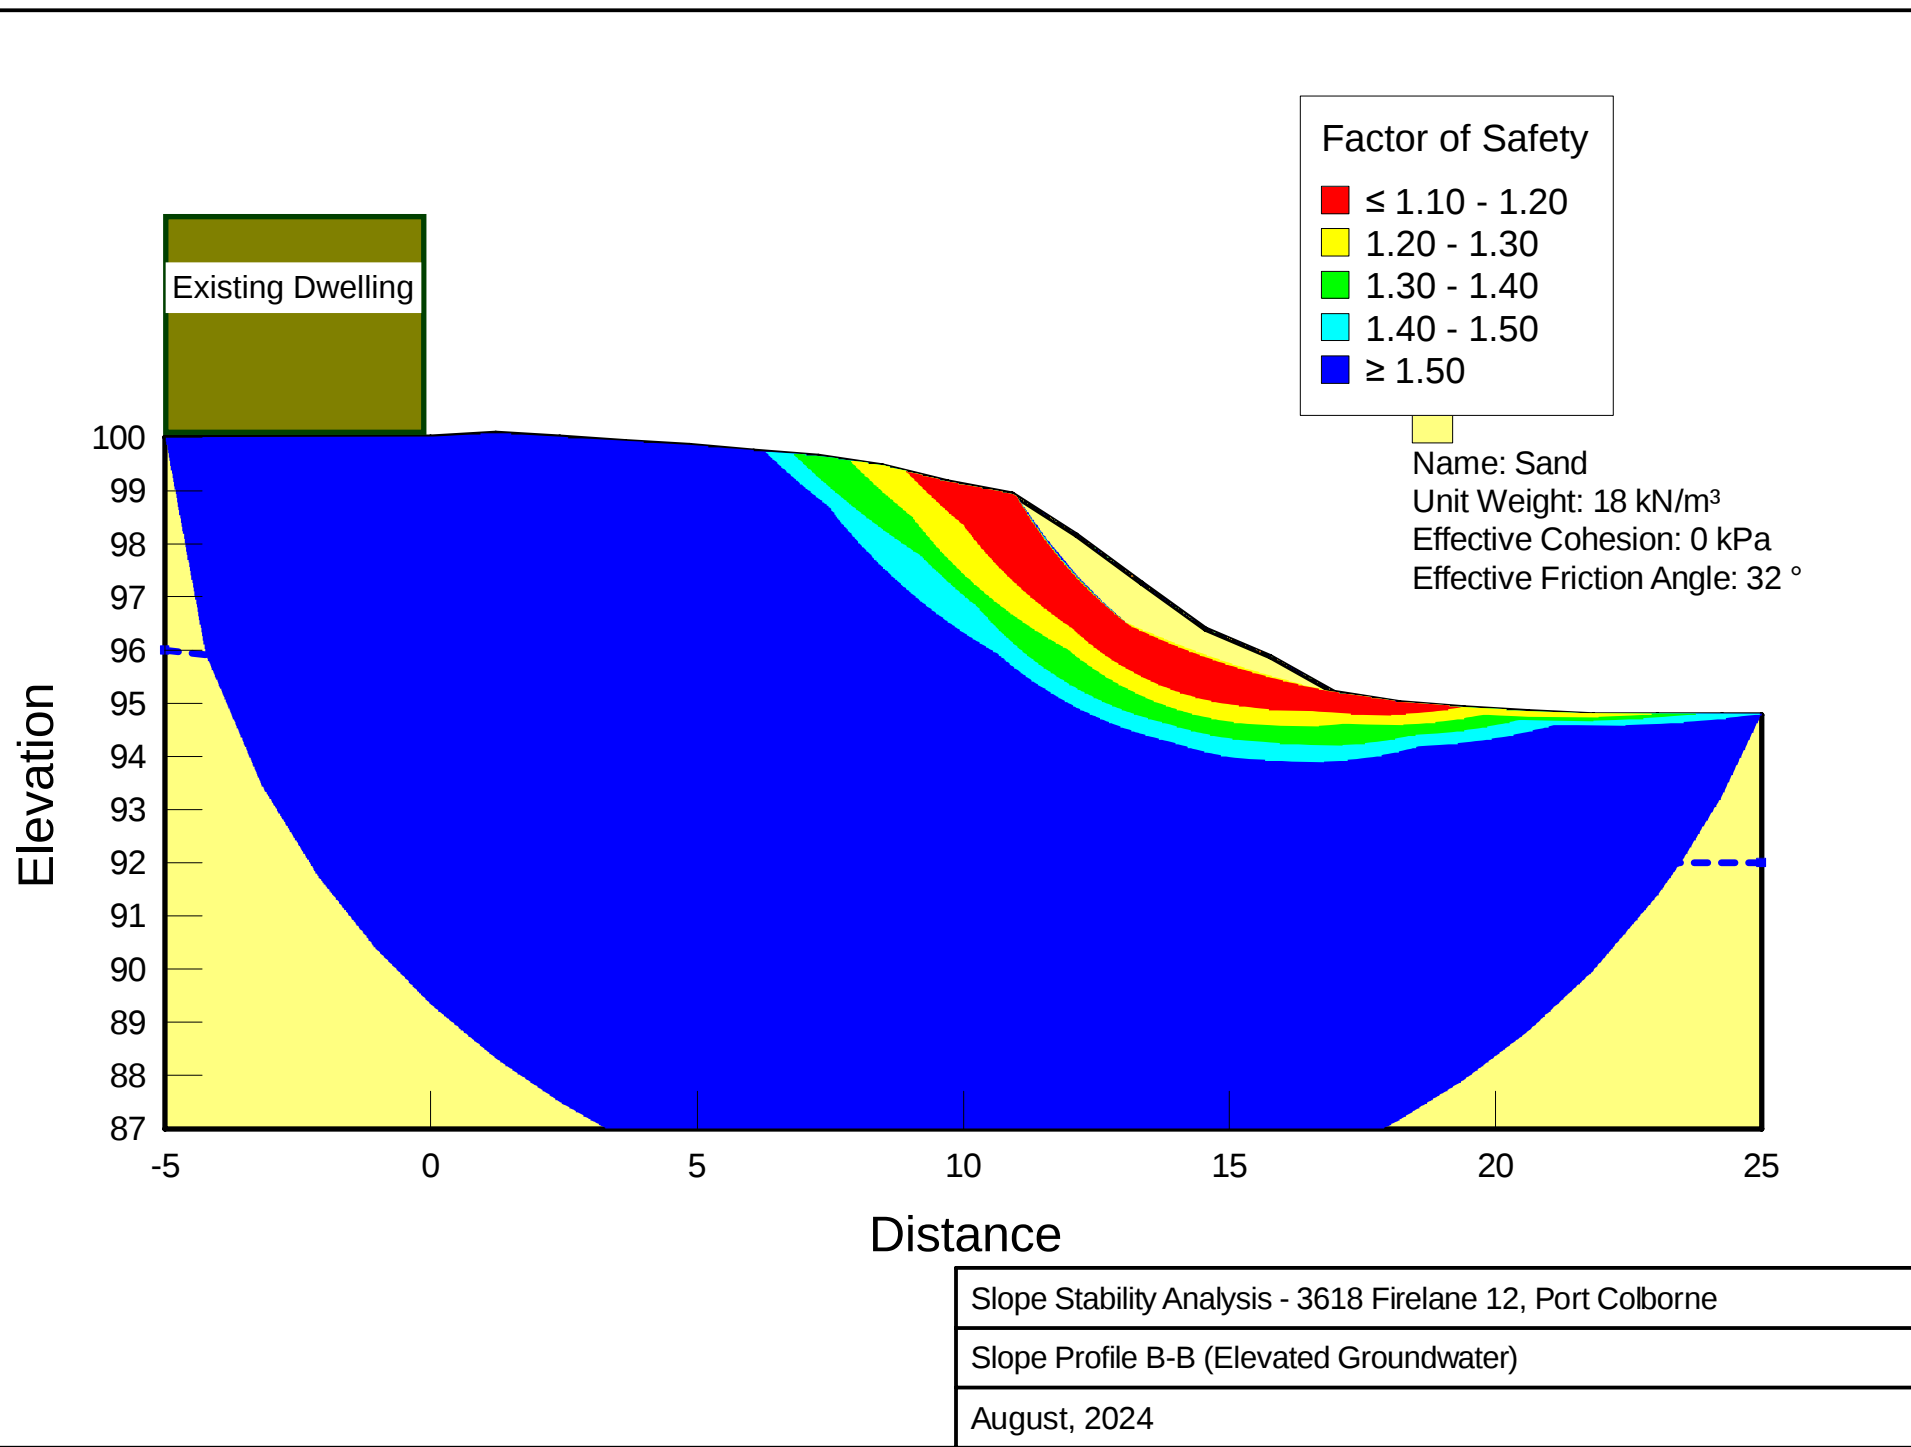
Slope Profile B-B (Normal Groundwater)

Based on our analyses, using the conservative assumptions noted above, the subject slopes were found to have minimum factors of safety of 1.2 for normal and elevated groundwater conditions, on the north side of the existing structure, locations approximately 4.0 and 9.0 metres north of the existing dwelling, for Profiles A-A and B-B respectively, as illustrated on Drawing No. 1, for the purposes of the proposed septic bed location.

With respect to the house, and using a factor of safety of 1.5 as a starting point, the top of stable slope location was determined to be at a distance of approximately 1.2 and 6.3 metres north of the existing dwelling for Profiles A-A and B-B respectively, and 7.0 metres south of the existing dwelling for Profile C-C, as illustrated on Drawing No. 1. Sample results of these analysis are attached to the end of this report. It is noted that theoretical surficial planes with lower factors of safety would exist, however these insignificant failure planes do not account for the stabilising effect of vegetation, nor would they impact the global stability of the slope.
