Re: Lock 8 Gateway Park Pavilion

A visual review was undertaken at the Lock 8 Gateway Park Pavilion on March 20, 2023. The original construction date is not known. The following details McIntosh Perry's observations and recommendations.

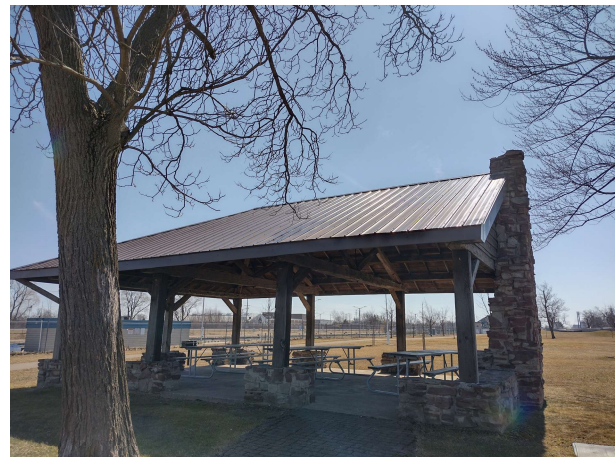
The structure consists of 9"x9" wood columns at approximately 11' on centre along the north, south, and east sides. The columns support rough cut wood trusses, purlins, roof rafters, and decking. Trusses include steel tie rods in the centre. Trusses are through bolted to columns using steel angle clips. Diagonal members between columns and trusses are nailed.
